# Manhole Inspection Summary

Manhole # S17GG\_004MH

Insp Date: **4/13/09 3:10 PM**

**Location** Address: **1601 WARWICK**

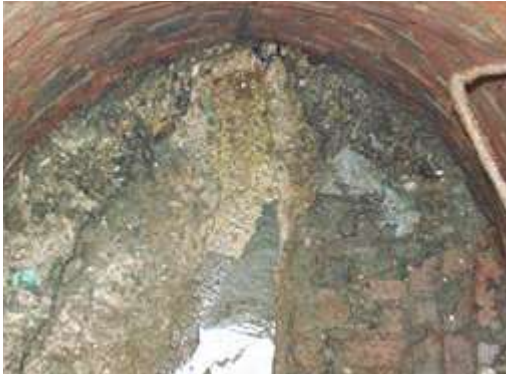
Defect 3

**Steps** Count: **3** Missing: **1** ☒ **Corroded**

**Surcharge** ☒ **Evidence Of Surcharge** Depth: **3** (ft.) ☐ Active Surcharge Present

STEPS CORRODED/EVIDENCE OF SURCHARGE

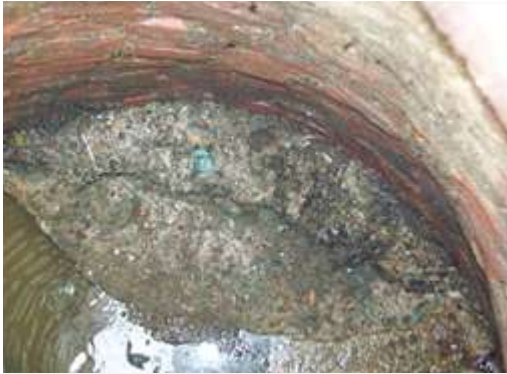
Defect 2

Condition: ☐ Sound ☐ Cracked ☐ Root Intrusion ☒ **Loose Brick** ☐ Deteriorated

Condition: ☐ Sound ☐ Cracked ☐ Root Intrusion ☐ Deteriorated ☐ Leaks ☒ **Debris**

LOOSE BRICKS CHIMNEY/ DEBRIS

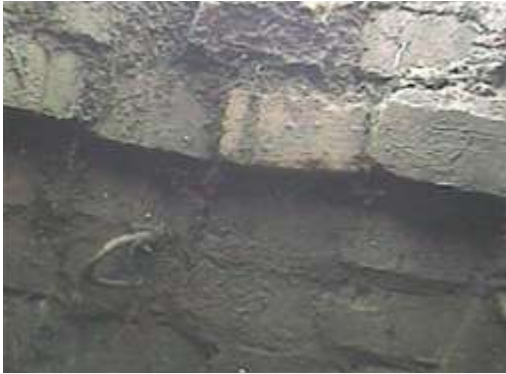
Defect 1

MISSING -CORRODED RUNG

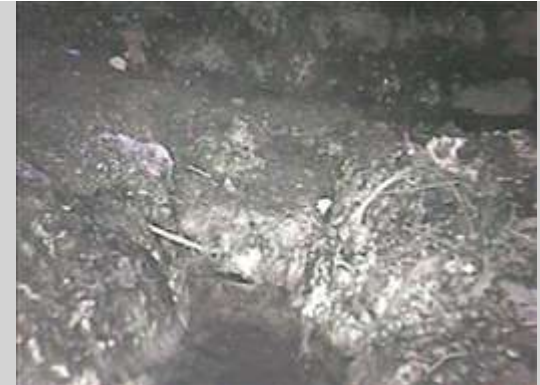
12 O'Clock Outflow

8 in. Circular Gravity Sewer  
Pipe Out @ 12 O'Clock

Deposits: ☐ None ☐ Mud ☒ **Sludge** ☒ **Debris** ☒ **Grease**

Silt Depth: **8** (in.) Deposits Extent: **Heavy**

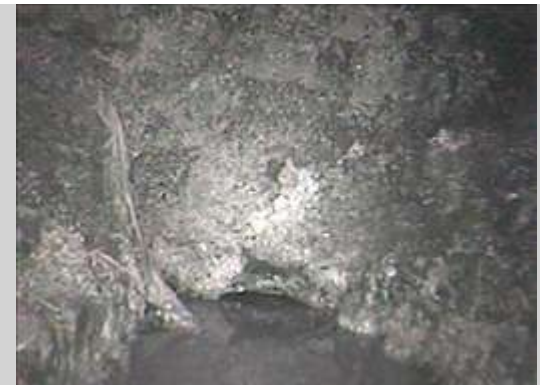
9 O'Clock Inflow

8 in. Circular Gravity Sewer  
Pipe In @ 9 O'Clock

Deposits: ☐ None ☐ Mud ☒ **Sludge** ☒ **Debris** ☒ **Grease**

Silt Depth: **7** (in.) Deposits Extent: **Heavy**
